Compromising the Seal

What causes Head Gaskets to Fail?

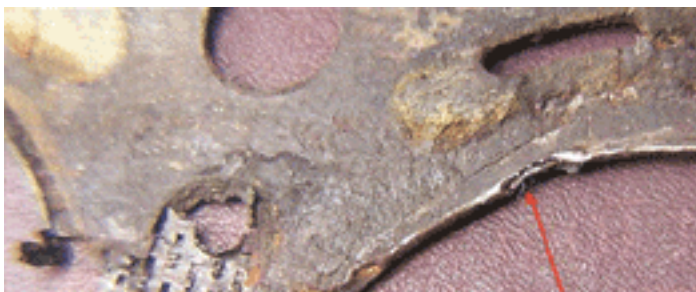
but expand 1.7 times faster than cast iron when they get hot. The difference in expansion rates creates a lot of motion and scrubbing between the head and block. If the head gasket can't handle this motion and isn't strong enough to withstand the shearing forces that occur every time the engine is started, run and allowed to cool back down, it will eventually leak.

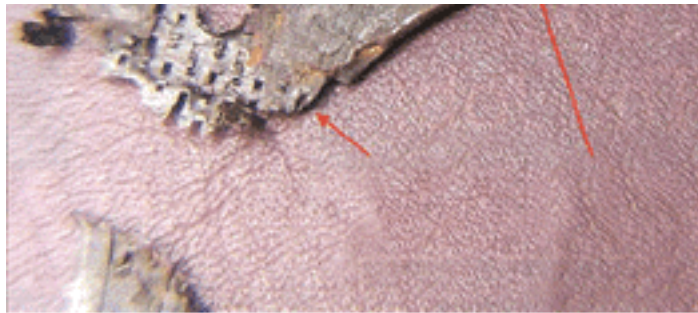
This detonation damage was caused by excessive combustion temperatures and excessive combustion pressures.

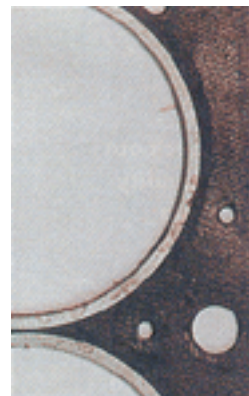
Loose assembly is evident by no or few compression marks on the gasket faces. The thickness of the gasket will be almost the same as on a new, uncompressed gasket. Look for leakage to occur in the first few hours after installation.

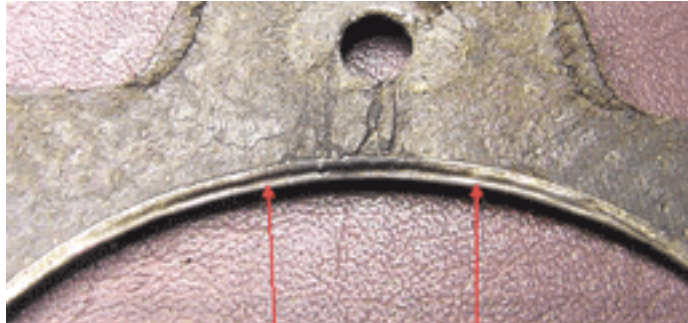
This shows damage to the head gasket consisting of denting of the combustion grommet caused by excessive combustion pressures.

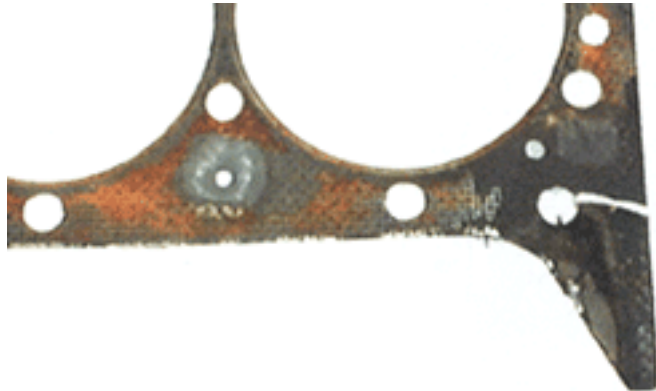
Head gasket damage can be traced to overheating, incorrect torque or detonation. Ensure that proper parts and procedures are used when installing the head gasket in your engines or failures are likely.

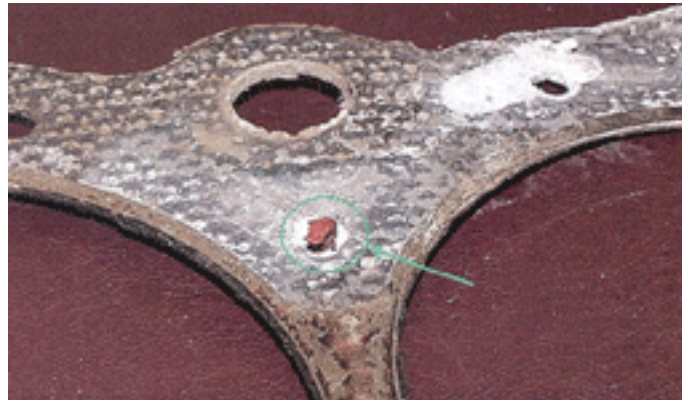
A failed head gasket can be traced to something outside the combustion chamber. Here, RTV sealant was lodged in the coolant hole.

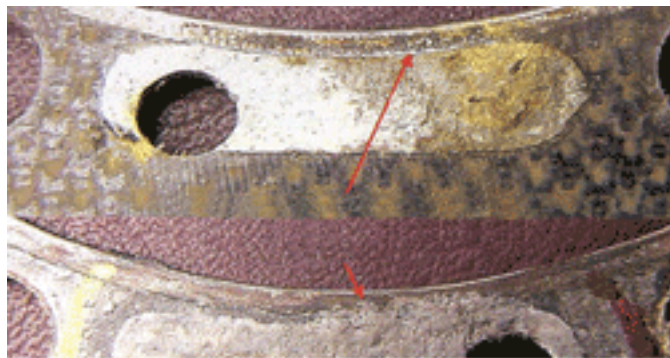
This damage was the result of an over-milled cylinder head. Note the coolant port overlaps the combustion grommet.

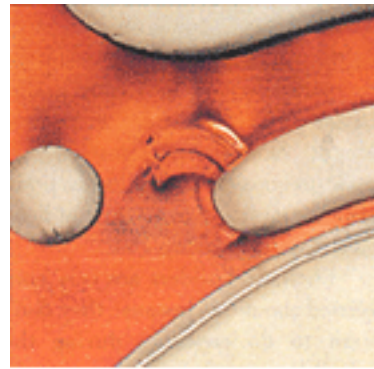
This is an example of entrapment. Gaskets and other components must be thoroughly cleaned before assembly. Any foreign material trapped between the mating surfaces will seriously impair the gasket's sealing performance.
